**Ashington Site 5 and Site 6, West Sussex:
Heritage Assessment**

Project No. 190240

Report No. 2019114

February 2020

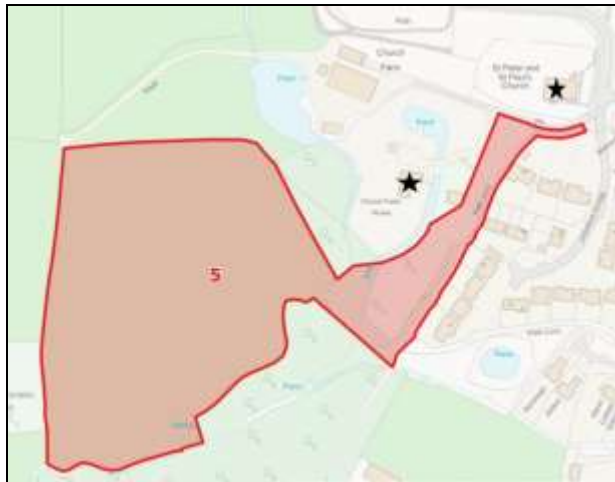
Site 5 in relation to the listed buildings

- 4.3 Two listed buildings are located within close proximity to the proposed access route (marked by stars on the map extracts below): the Parish

Church of St Peter and St Paul (Grade II* - NHLE Ref. 1027442) and Church Farmhouse⁴ (Grade II – NHLE Ref. 1353978). The latter also marks the location of the non-designated moated site. These have been assessed for potential impacts on their setting.

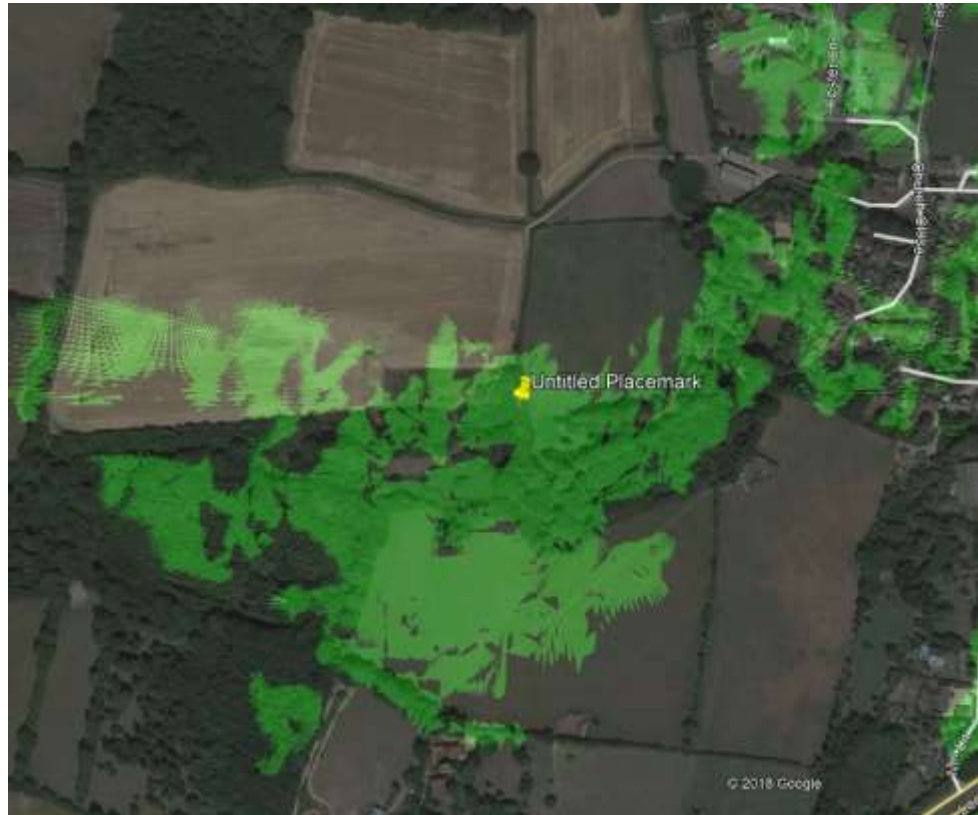
⁶ Derived from the viewshed tool within Google Earth, based on a viewer located at the approximate location of the stone building surveyed in 1999 (yellow pin), with a viewing height of 2m above ground level. The theoretically visible ground is coloured green.

the downland in the distance. Views between the house and the bath-house will also have been important, as was the main approach along the ridge from the west. The land to the north formed part of the rural landscape associated with the villa, but was of lesser significance given the lack of significant intervisibility from most of the villa complex as currently understood (see viewshed below⁶).
